International Organisation for Migration

Flood Resilient Shelter in Pakistan

Phase 2: Evidence-Based Research

October 2017

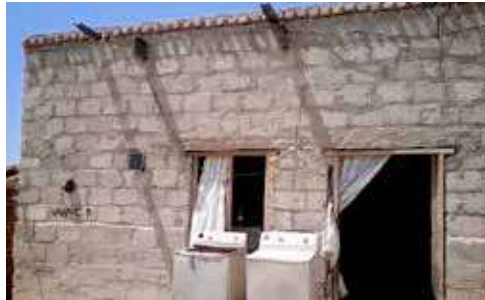
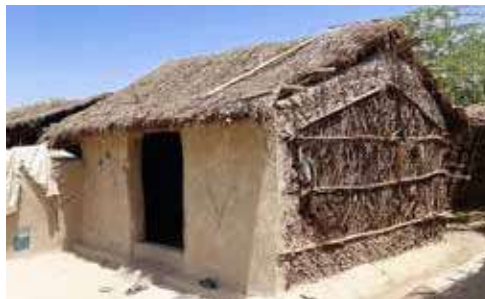
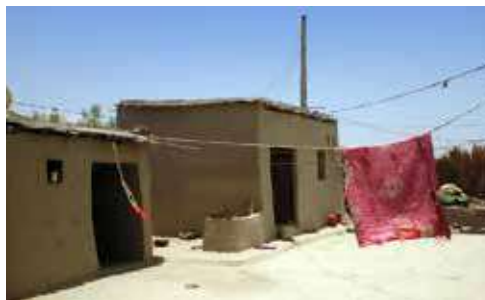
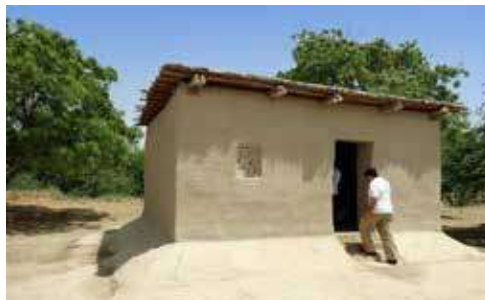
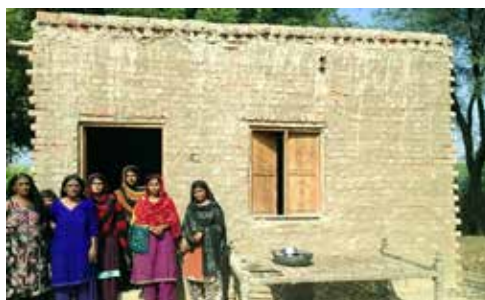
Figure 3 - Five wall typologies: top to bottom, concrete block, loh-kat, adobe, layered mud, fired brick

Of the five wall typologies four are loadbearing whilst the fifth, loh-kat relies upon a framework of vertical and lateral timbers which are plastered either side. Loh-kat is typically lighter weight with foundations made by simply embedding the vertical timbers into the ground. Of the four loadbearing typologies three can be considered as masonry as they are assembled from pre-made units whilst layered mud is built by hand in-situ. The loadbearing typologies require strip foundations in order to support them, with trenches dug and subsequently filled with masonry or compacted soil. Roofs may be flat, singled or double pitched and in some cases conical where a shelter is round on plan, although no round shelter were found in the random field survey.

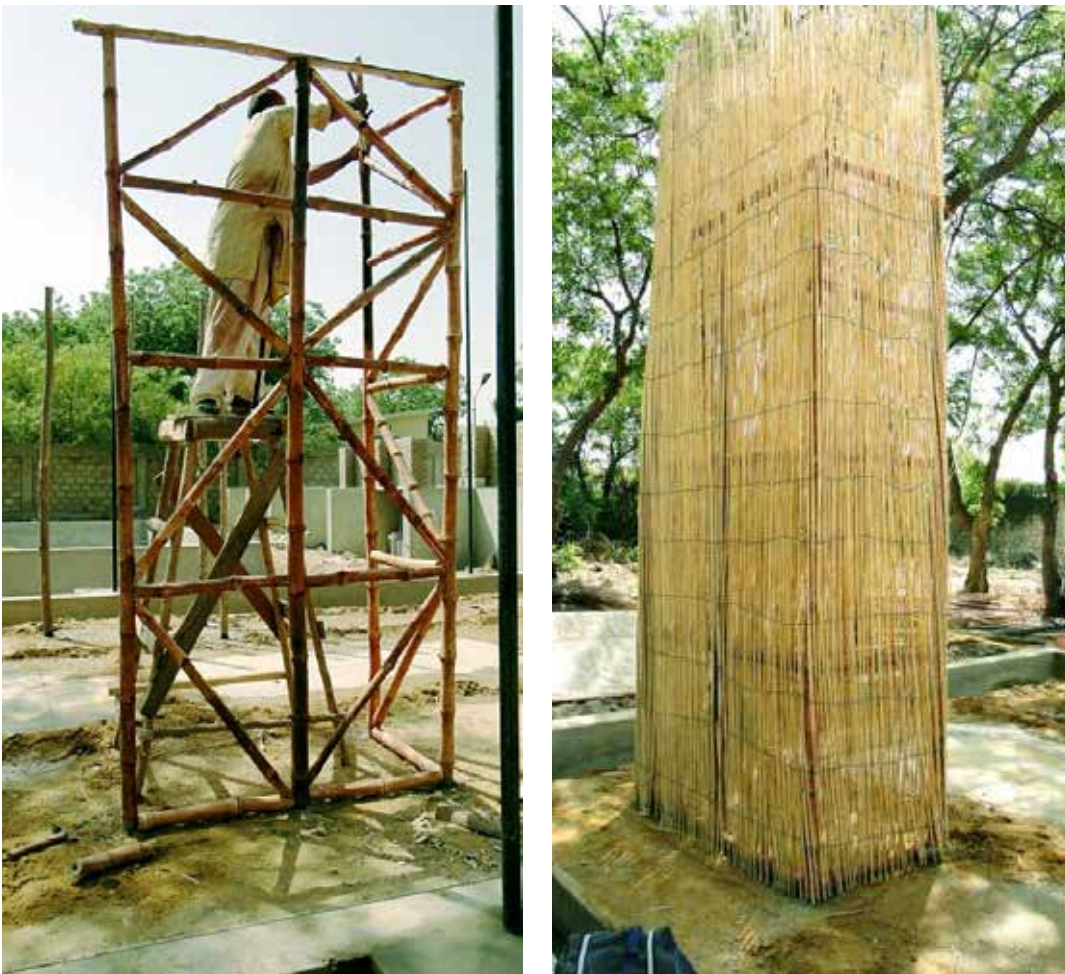
Figure 4 Loh-kat panel at testing facility made from bamboo frame and chicks matting. The next step is to apply plaster to the chicks matting. Note that the bamboo frame requires lots of diagonal bracing in order to make it stable. With many loh-kat shelters recorded as visibly leaning over it is most likely due to insufficient bracing.

Traditional Loh-kat construction consists of a lattice of interwoven timber strips or branches plastered either side with similar variations in existence all over the world. By contrast some Loh-kat shelters built in the response consisted of a bamboo frame with verticals at increased spacing and a reed matting known as ‘chicks’ fixed to one side. Key informant interviews suggest that this was a response to material depletion, a factor which could help to explain the relatively poor performance of this wall typology under certain criteria.

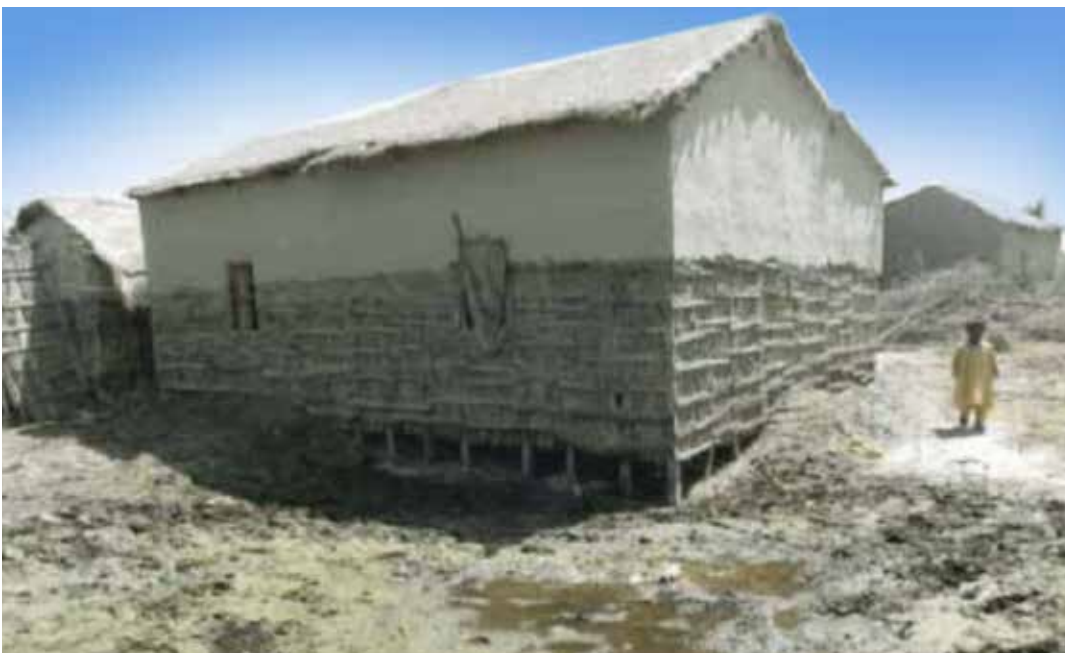
Figure 16 - Loh-kat shelter after flooding (UN-HABITAT 2010)

For the purpose of this study sacrificial mass is defined as any part of the shelter whose primary purpose is to protect the main structure and which does not contribute to its structural integrity. These elements act as a ‘wearing’ layer which degrades over time

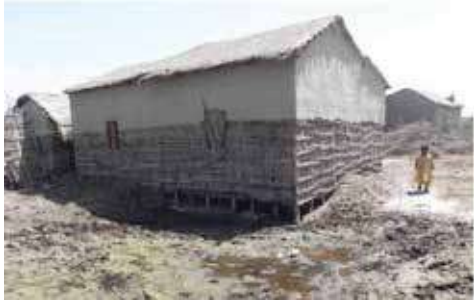
Typology and Hazard	<ul style="list-style-type: none"> Key observations and <u>Potential areas to investigate through testing</u>
<p>Loh Kat – Standing water</p>

<ul style="list-style-type: none"> Foundations eroded Mud plaster is washed away Importantly the bamboo/timber frame remains in place meaning that the roof remains intact Walls can be repaired once water has receded <p style="text-align: right;"><u>Foundation design</u></p> <p style="text-align: center;"><u>Redundancy of walls for improved roof support</u></p> <p style="text-align: right;"><u>Lime stabilised plaster</u></p> <p style="text-align: right;"><u>Raised floors and plinth protection</u></p>
<p>Fired Clay – Standing water</p>

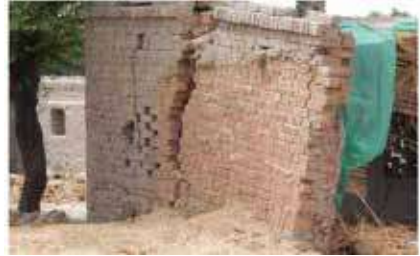
<ul style="list-style-type: none"> Bricks are largely water resistant and remain intact Where used with mud mortar the mud is washed away, the wall no longer has cohesion and collapse follows Water-logged shallow foundations are subject to settlement, resulting in cracking and collapse of walls. <p style="text-align: right;"><u>Foundation depth</u></p> <p style="text-align: right;"><u>Upper and Lower ring-beam</u></p>

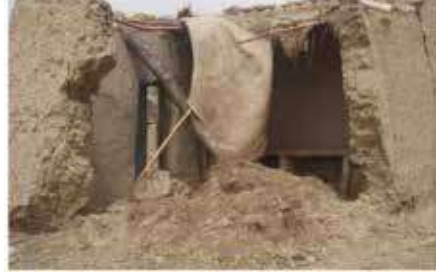
<p>Adobe/Mud brick – Standing water</p>

<ul style="list-style-type: none"> Walls dissolve and collapse With no redundancy in the structure the roof also collapses Water-logged shallow foundations are subject to settlement, resulting in cracking and collapse of walls. <p style="text-align: right;"><u>Lime stabilisation</u></p> <p style="text-align: center;"><u>Wall tie-ing and redundancy (buttresses etc)</u></p>

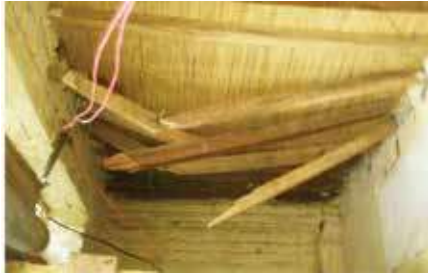
Mud roofs – Rainfall

- Mud roofs become saturated with rainfall causing failure of roof covering and or the roof structure.

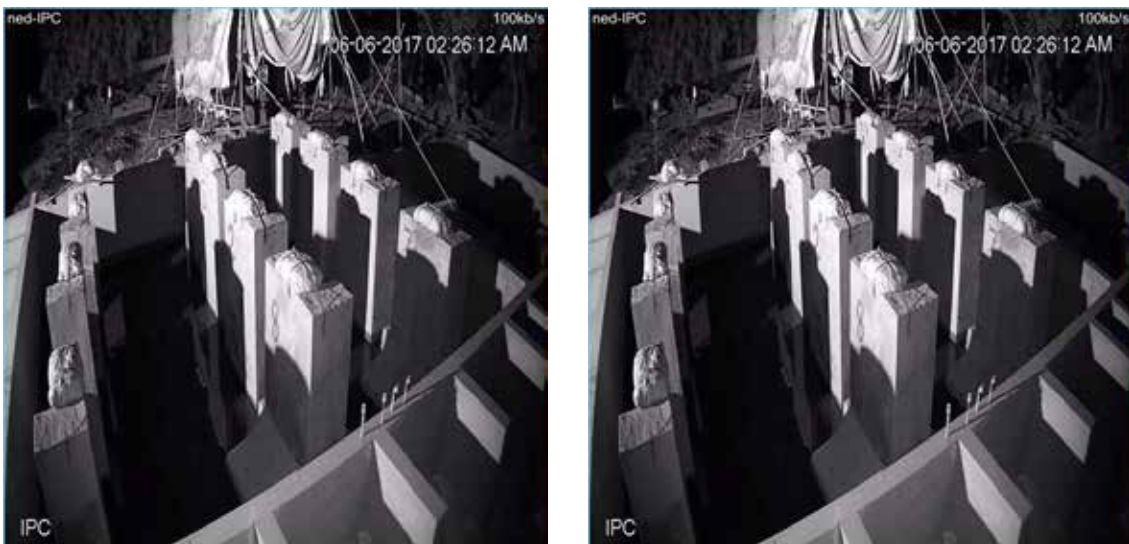
Figure 1 View of flood tank from two different angles

The flood simulator consists of two large tanks. One of the tanks is named as flood tank and the other is the reservoir to hold the water to be fed into the flood tank. These tanks are connected to each other with pipes and pumps to transfer water from one tank to the other. The inlets in the flood tank are placed in such a way that the clay structures constructed within it are not affected by turbulence of inflow. Figure 1 shows the view of flood tank from two different points. It can be seen that wall panels are constructed inside the flood tank which. The constructed walls are also provided with some loading conditions as seen in Figure 1, discussed in succeeding sections of the report.

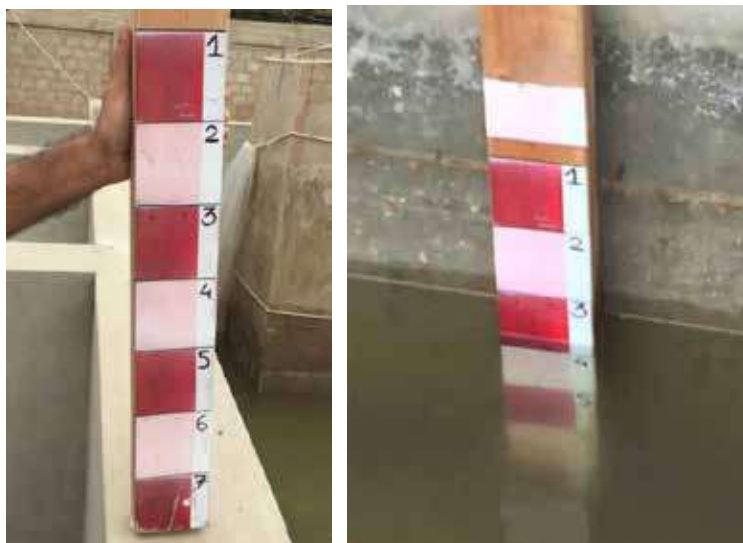
Figure 2 Staff gauge for measurement of water depth in flood tank

The flood tank was filled with water with constant supply to a depth of 600 mm at a rate of 122 mm per day such that the water reaches 600 mm after 5 days. A staff gauge for measurement with custom calibrations was installed in the flood tank as show in Figure 4.

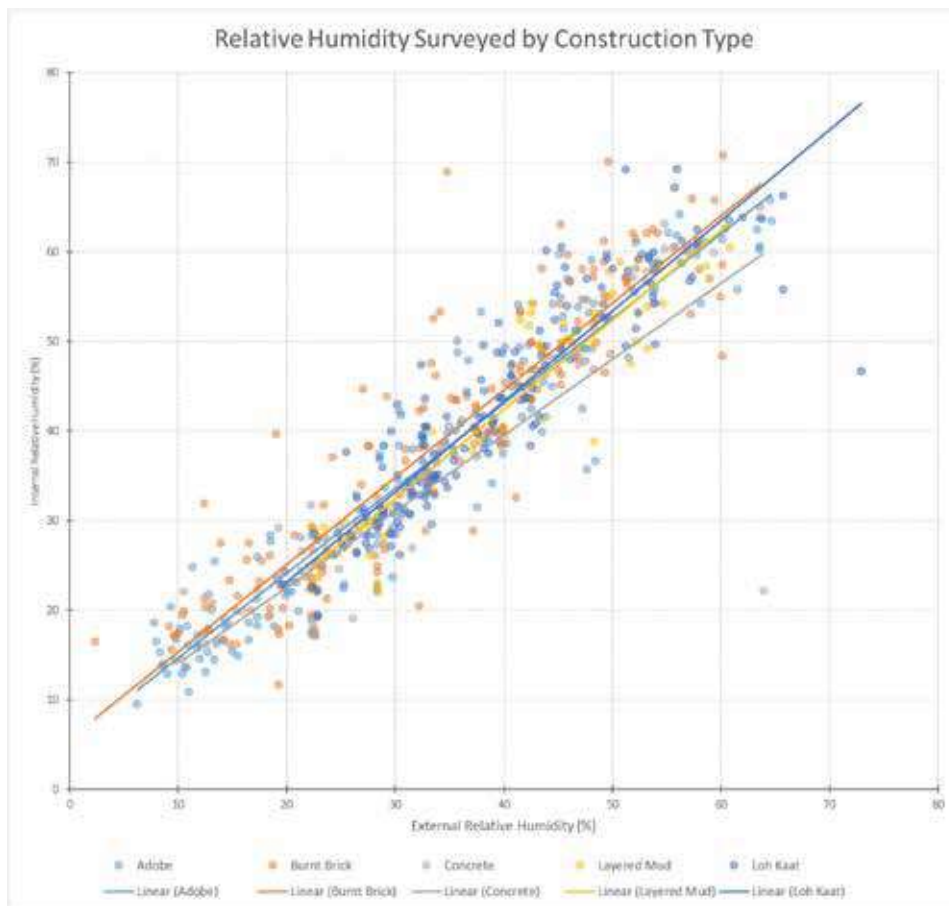
Figure 6 Relative Humidity measured, internal versus external
